NBSIR 75-669

# Failure of Flexible Brass Gas Appliance Connectors

J. R. Ambrose and J. Kruger

Failure Analysis Report

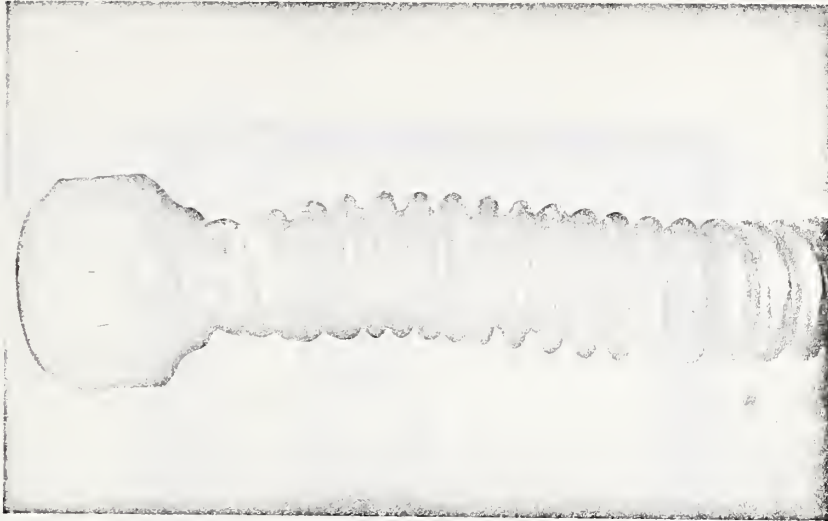
Visual examination of the specimens revealed discoloration and blue and white residue in the area located near the extremities of the tubing sections, where couplings were attached (Fig. 2a). In addition to this,

Fig. 2a Close-up view of an end of one tubing, showing where the corrosion attack was located.

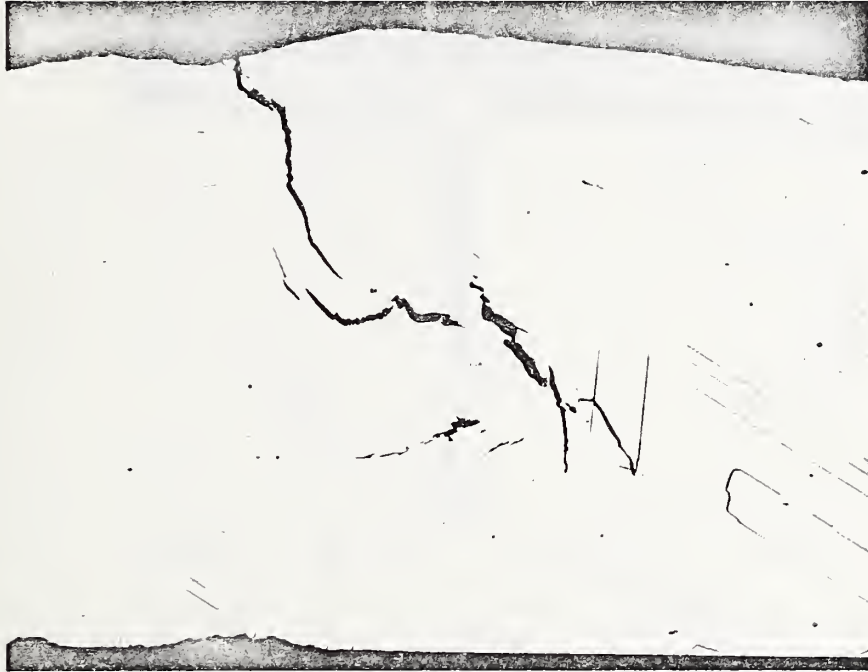
Optical micrographs were made of a specimen which was sectioned from the flexible tubing in an area near one of the major fracture sites. Cracks can be observed throughout the body of the material and are highly branched (Fig. 4). When the specimen surface was chemically etched two important observations can be made: (1) the metal microstructure is of rather large grain size, and (2) the cracks are largely transgranular in nature, propagating through grains rather than through grain boundaries (Fig. 5).

Fig. 4 Optical Micrograph (x200) of a cross section of the flexible brass tubing, showing the branched nature of the cracks.

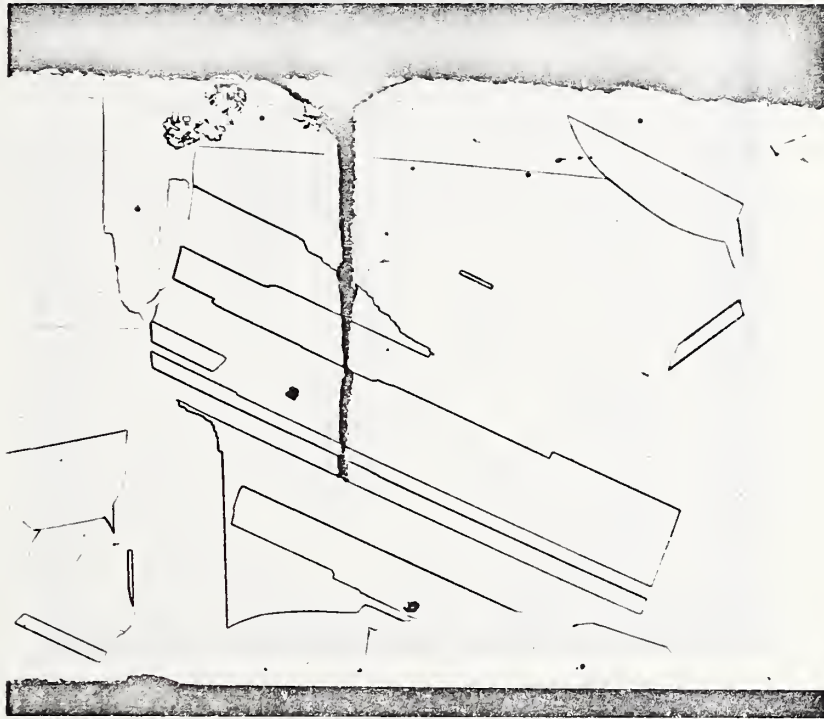
A comparison of the optical micrographs taken of cracks in this material (Fig. 5) with those observed for stress corrosion cracking of 70-30 brass in non-tarnishing aqueous ammonia solution show the morphology of cracking to be quite similar (Fig. 7, from (4)). Furthermore, the particular heat treatment of this brass which resulted in the large grain size (Fig. 5)

would be expected to cause an increase in susceptibility to stress corrosion cracking (5).

Fig. 5 Optical Micrograph (x200) of a cross section of the flexible brass tubing, etched in 1 part water ( $\text{H}_2\text{O}$ ), 1 part hydrogen peroxide ( $\text{H}_2\text{O}_2$ ), and 1 part concentrated ammonium hydroxide ( $\text{NH}_4\text{OH}$ ), showing the metal microstructure. Cracks are predominantly transgranular.

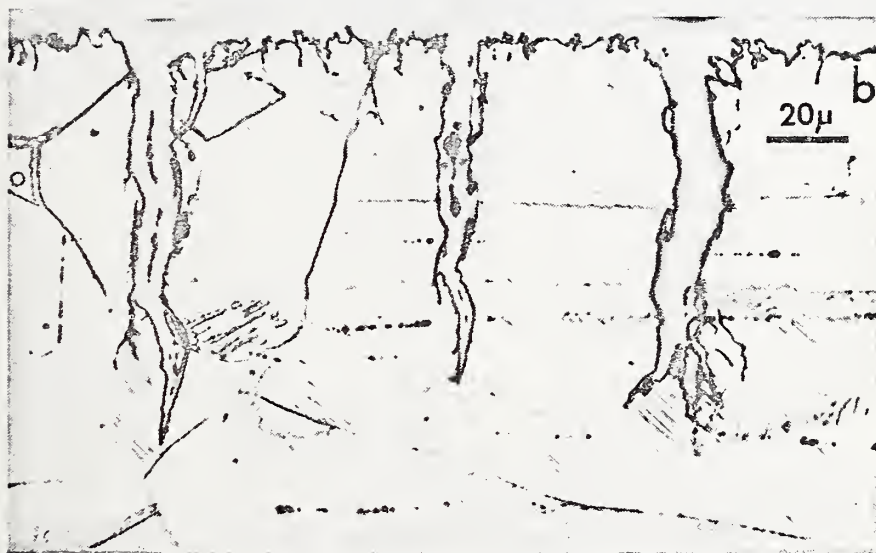
Fig. 7 Optical Micrograph showing stress corrosion cracks in 70-30 brass exposed to aqueous ammonia solution (from (3)).

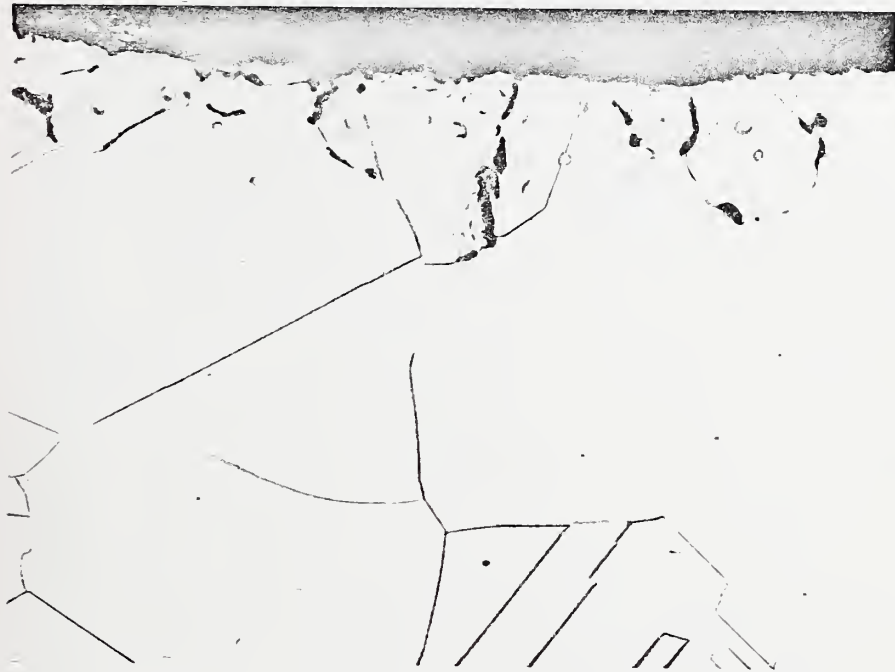
Finally, a test specimen was cut from a section of the brass tubing, bent once to simulate treatment during installation of the coupling unit, dipped into a sample of the leak detector solution, then placed into a sealed glass container. The test exposure was allowed to proceed for two weeks, after which the specimen was removed, sectioned, and mounted for metallographic examination. Although the extent of crack propagation is less than that in the failed specimens, the initial stages of cracking are evident in Fig. 8. It should be remembered that service failures were reported to have taken from 3 to 6 weeks to occur, while the short term laboratory test was all that was possible, within the time limitations set to prepare this report.

Fig. 8 Optical Micrograph (x500) of the cross section of a 5 cm specimen of brass tubing exposed for two weeks to the leak detector solution, then etched as in Fig. 5, showing initiation of cracking at the metal surface.
